SEVENTH SEMIANNUAL STATUS REPORT
VOLUME II - APPENDIX A

ENERGY EFFICIENT ENGINE
COMPONENT DEVELOPMENT AND INTEGRATION PROGRAM

**ENERGY EFFICIENT ENGINE
HOLLOW FAN BLADES**

FINAL TECHNICAL REPORT

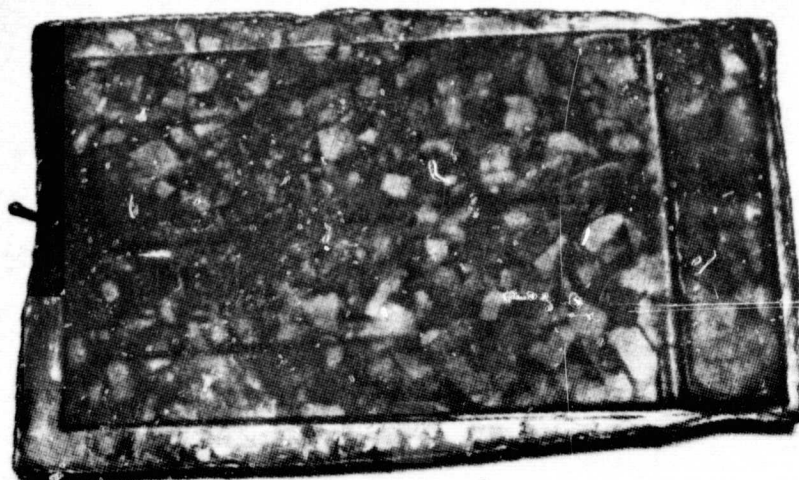
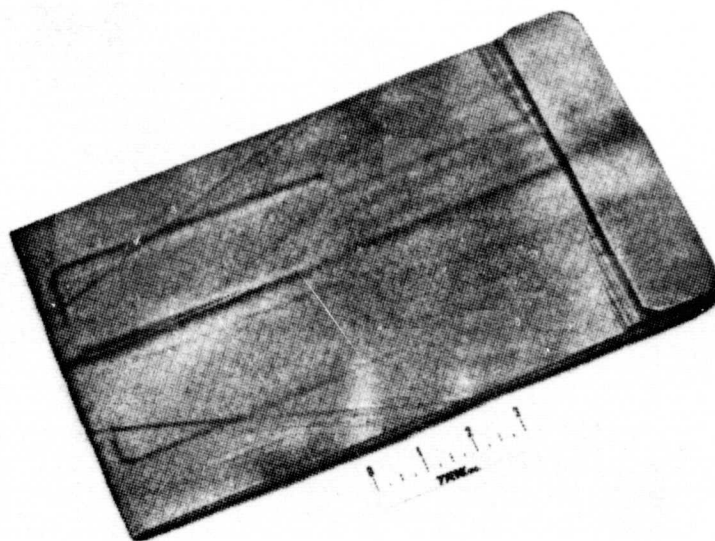
DS8, 9 and 10 after HIP using the modified cycle are shown in Figures 58 through 60. Visual examination indicated that the HIP run was successful except for a core shift in DS9. (An investigation of the core shifts was discussed for the assembly of the remaining diamond specimens.) The HIP diamonds were evaluated by X-ray and ultrasonic C-scan. Some differences in the radiographs were observed when comparing DS8 with DS9 and 10. It was observed that delineation of individual ply edges was particularly evident for DS10 and somewhat evident for DS9; however, ply edges for DS8 were not delineated and instead a blending of color or tone of the X-ray was observed. These differences are not illustrated herein because the radiographs do not reproduce well unless there are gross differences in color tone. C-scan inspection of the diamonds indicated no defects larger than 3/64-inch for DS8 but indications were present for DS9 and 10. An example is shown in Figures 61 and 62 when comparing DS8 and DS10.

Figure 59. Diamond Specimen 9 After HIP.

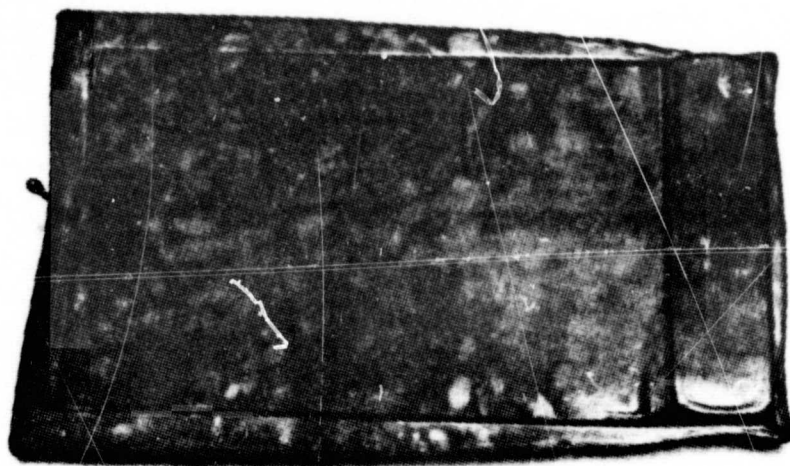
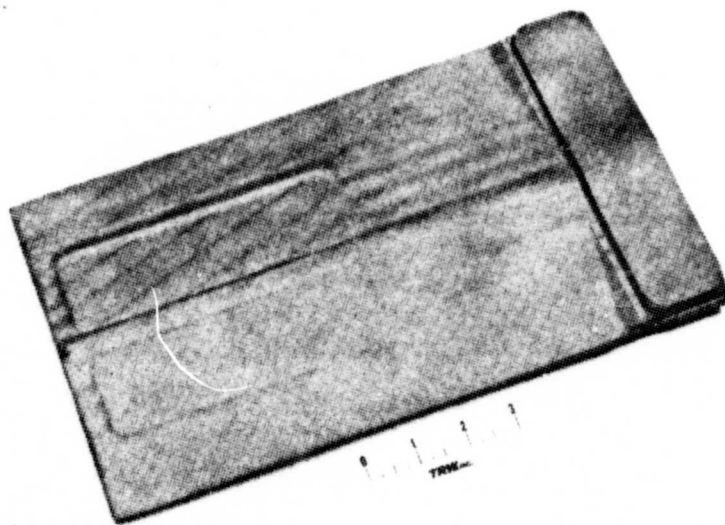
Dimensional analyses indicated that the three diamonds met the required blueprint dimensions (see Figure 2) except for the core shift area in DS9. Selected areas were sectioned for metallography and evaluated. Metallographic evaluations confirmed that disbond areas were present in DS9 and 10. These disbonds were due to a can leak at some stage of the HIP cycle after the can had formed around the plies. Typical results are shown in Figures 63 through 66. For the diamond specimen TIG welded in argon (No. 8) the vacuum outgas appeared to remove most of the adsorbed gases. Figure 64 shows one area where voids at the bond line were observed after reviewing literally hundreds of bond lines. Delineation of bond lines due to gases from welding were not observed for DS9 or 10; however, disbonds and incomplete fill at ply endings were present due to the can leak. The questions as to where and/or why the cans leaked remained to be answered. The welds undergo a compressive force during HIP except where the evacuation tube is placed. The weld in this area may develop a shear stress. Modification of this tube area as discussed before was made for future HIP runs.

Figure 60. Diamond Specimen 10 After HIP.

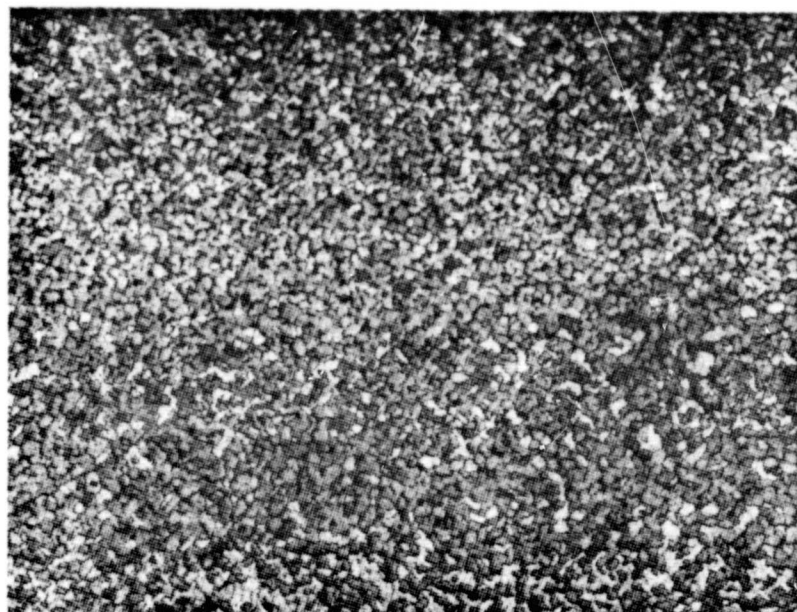
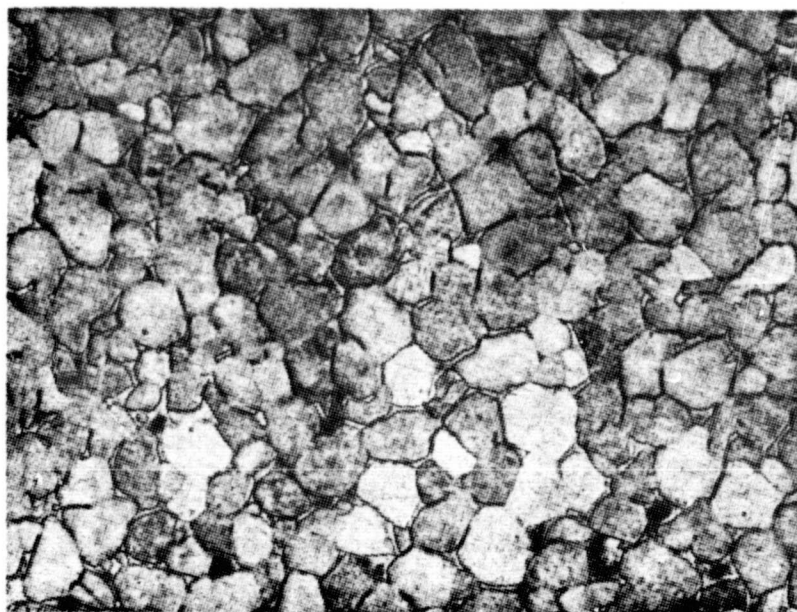
Figure 63. Microstructure in DS 8 at Several Areas. Etchant 96 H₂O-2HNO₃-2HF.

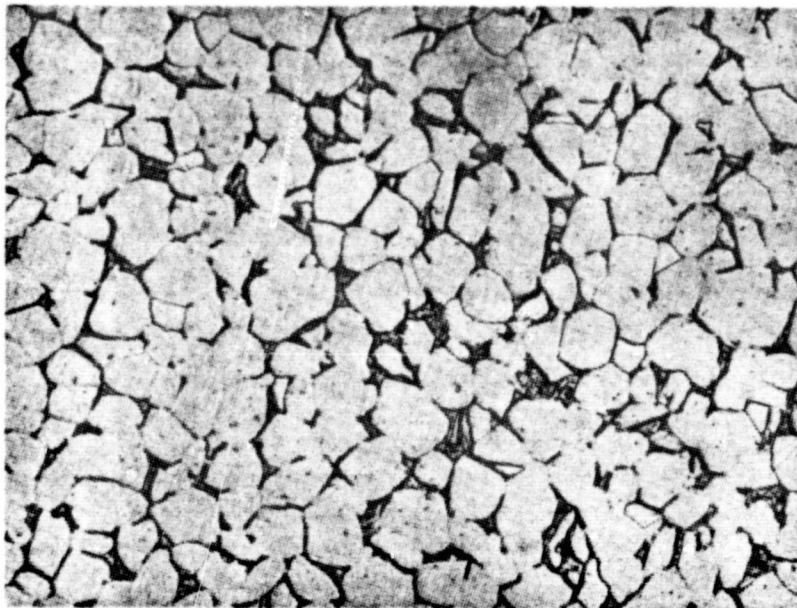
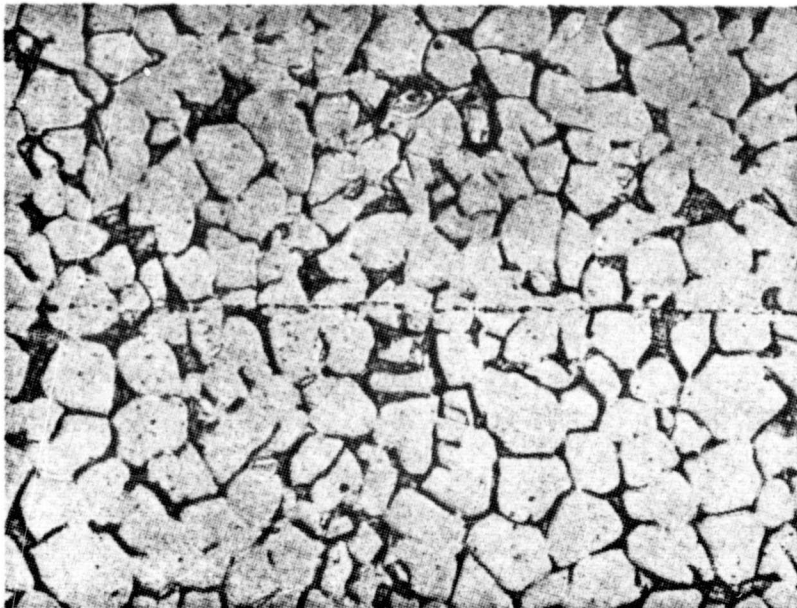
Figure 64. Microstructures in DS 8 at Several Areas.
Etchant 60 H₂O-35HNO₃-5HF. 500X

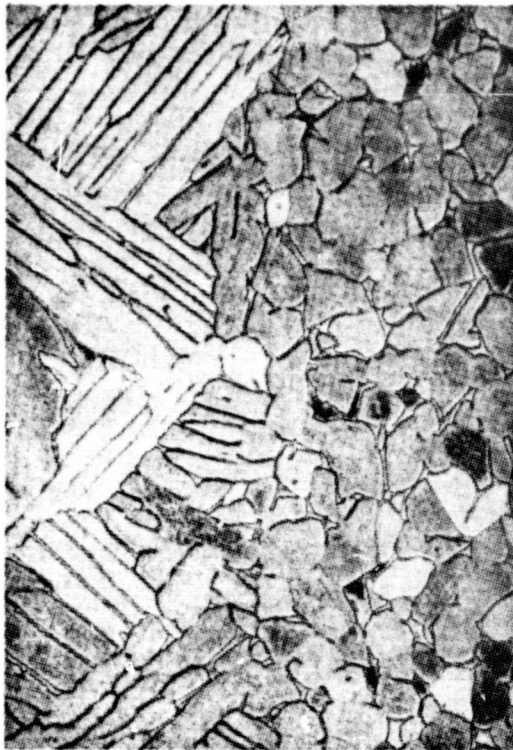
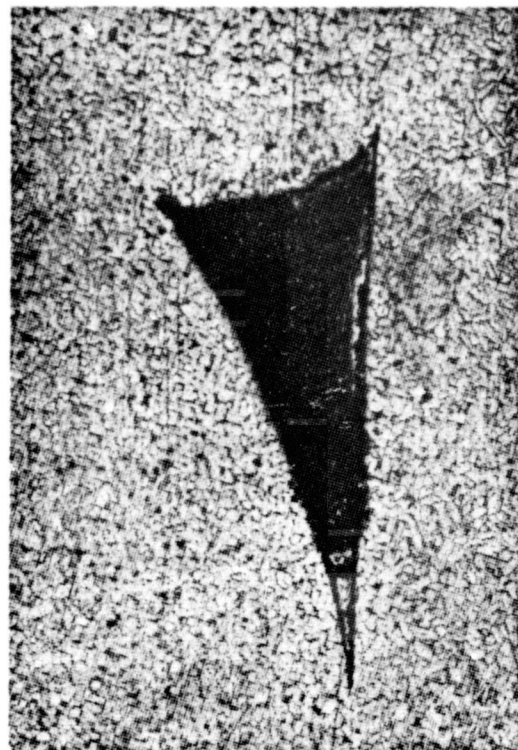
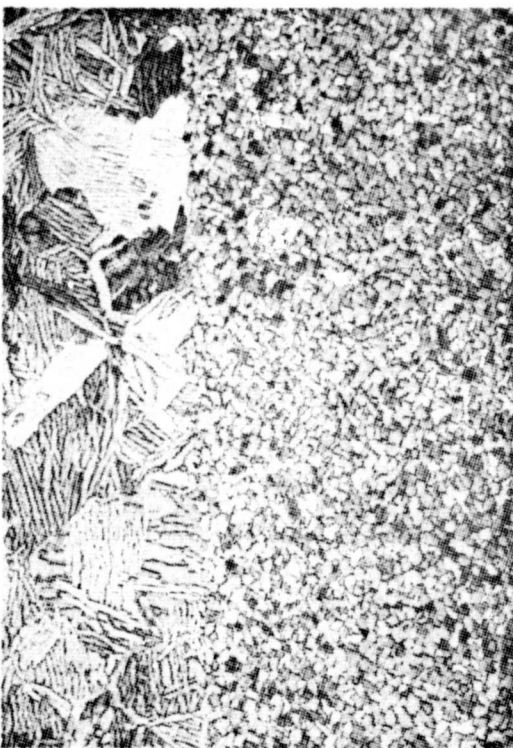
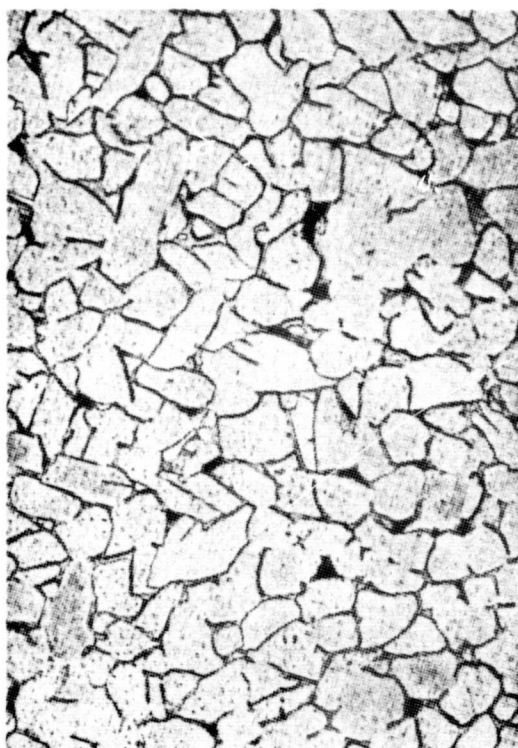
Figure 65. Typical Microstructure in DS 9 at Several Areas.

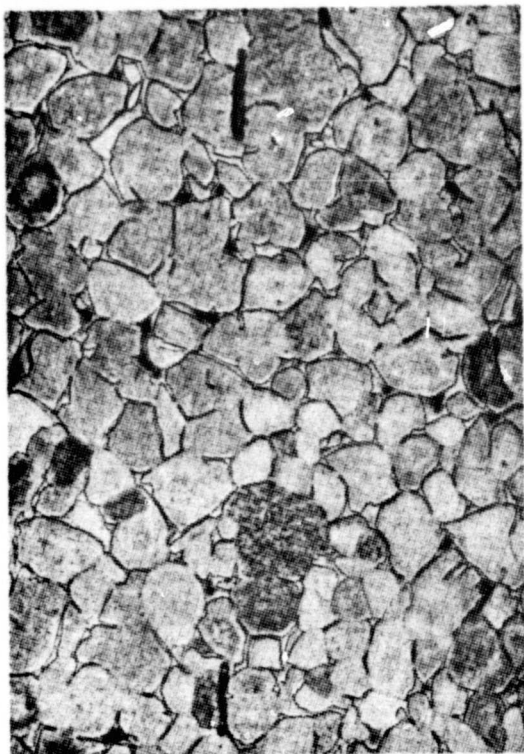
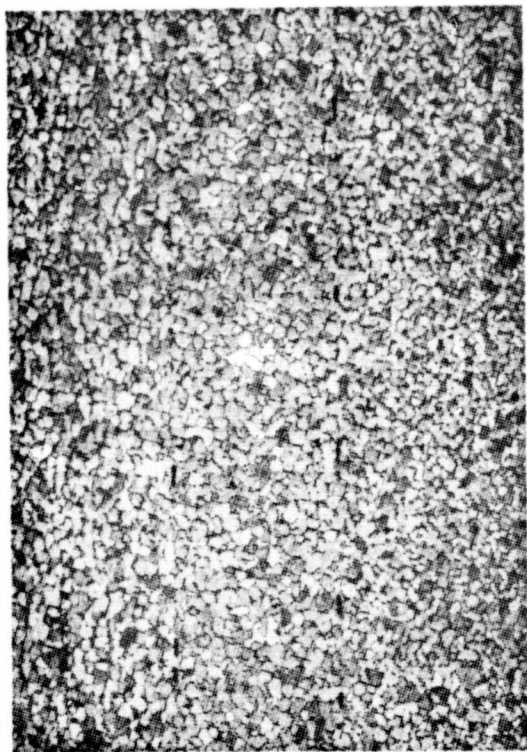
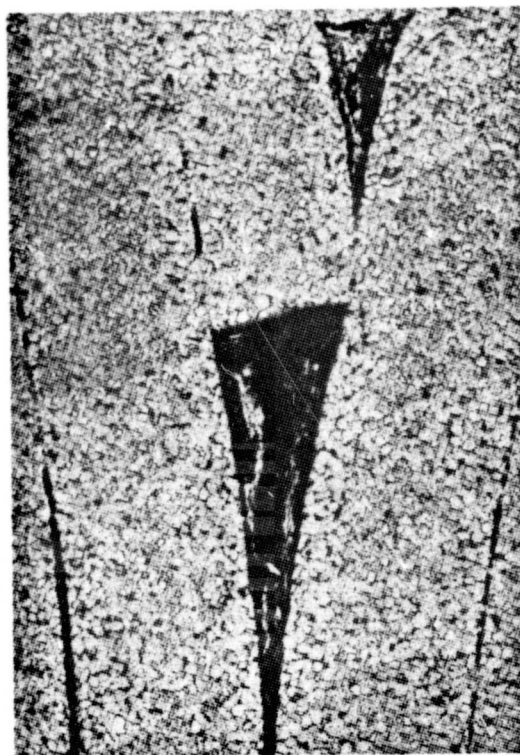
Figure 66. Typical Microstructures in DS10 at Several Areas.

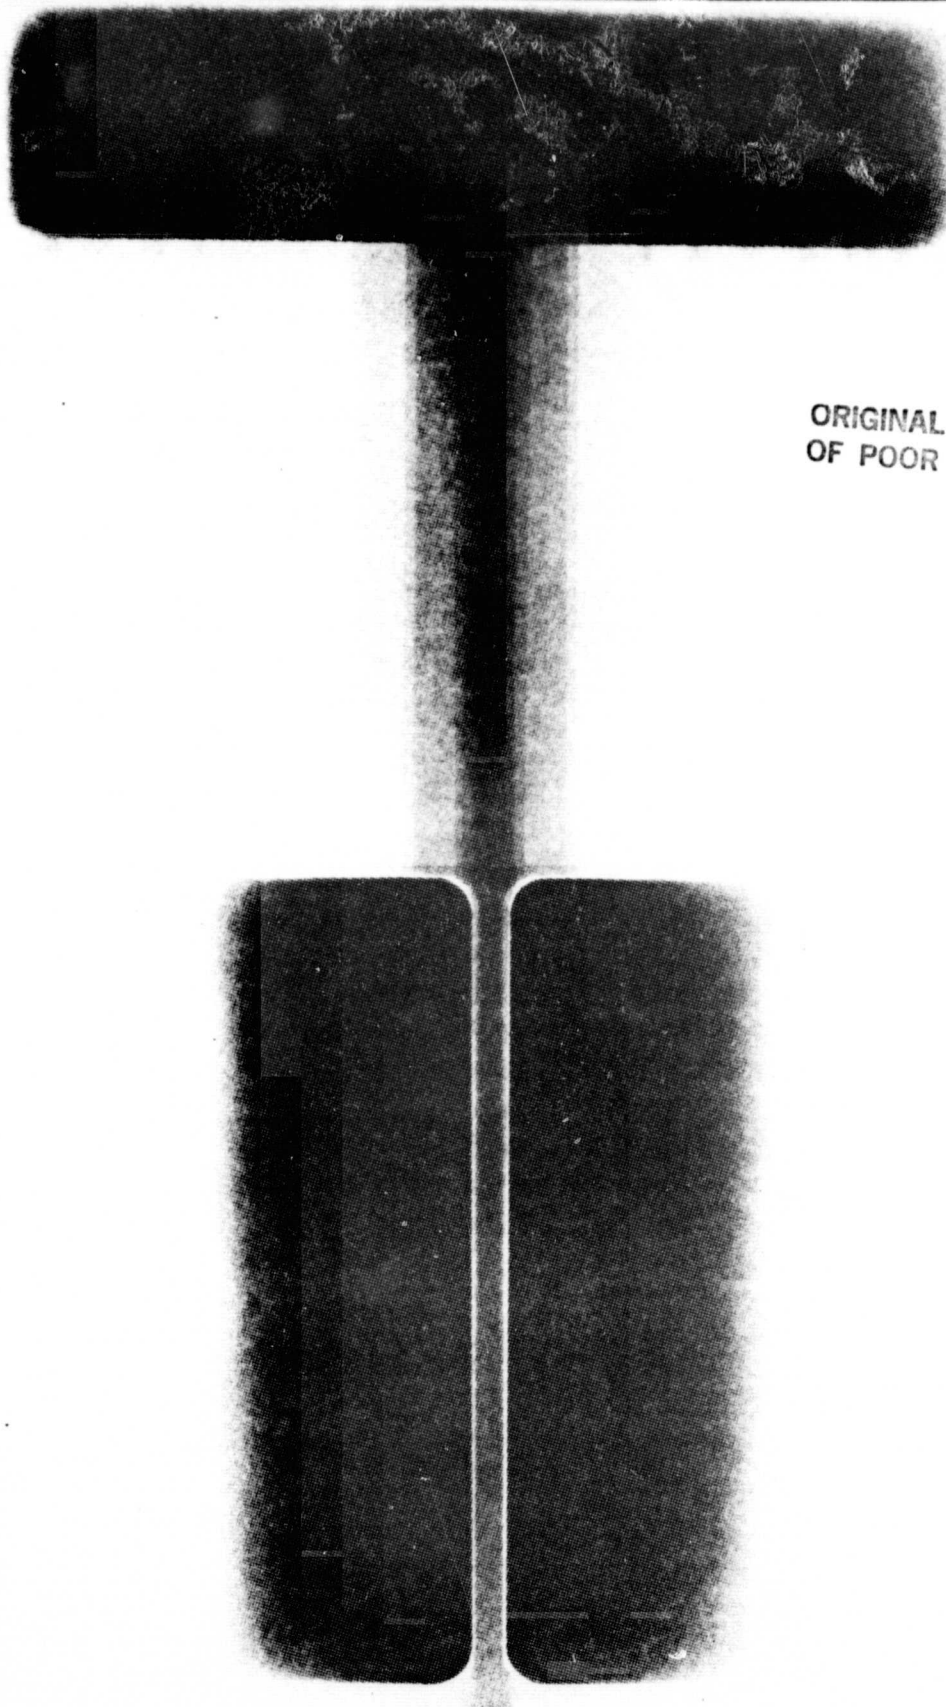
The first two diamond specimens fabricated for delivery to P&WA were DS13 and 15. Visual examination of the diamond specimens after HIP indicated a successful run. Both specimens were heat treated (1750°F/1 hour/FAC + 1300°F/2 hours/AC) after HIP while in the mild steel can. After stripping the can it was observed that both cans were leakers with DS15 appearing to be better bonded in all areas except the root. The poor bond areas in DS13 were obvious after HIP because the surface was "bubbled." This feature was due to expansion during heat treating of the entrapped argon gas from the HIP run. X-rays of these specimens after HIP indicated that the cores remained in position during the HIP cycle (see Figures 68 and 69); however, DS13 cores were about 0.050-inch farther apart than blueprint requirements. DS15 was submitted for ultrasonic C-scan evaluation. Based on experience gained with interpreting the C-scans there appeared to be some indications (unbonded areas) present in DS15 as shown in Figure 70. The delineation of the plies in the Figure 68 X-rays has also been a good nondestructive evaluation of ply disbonds. In a well bonded part ply edges are not well delineated.

Figure 68. X-Ray of DS 13 After HIP.

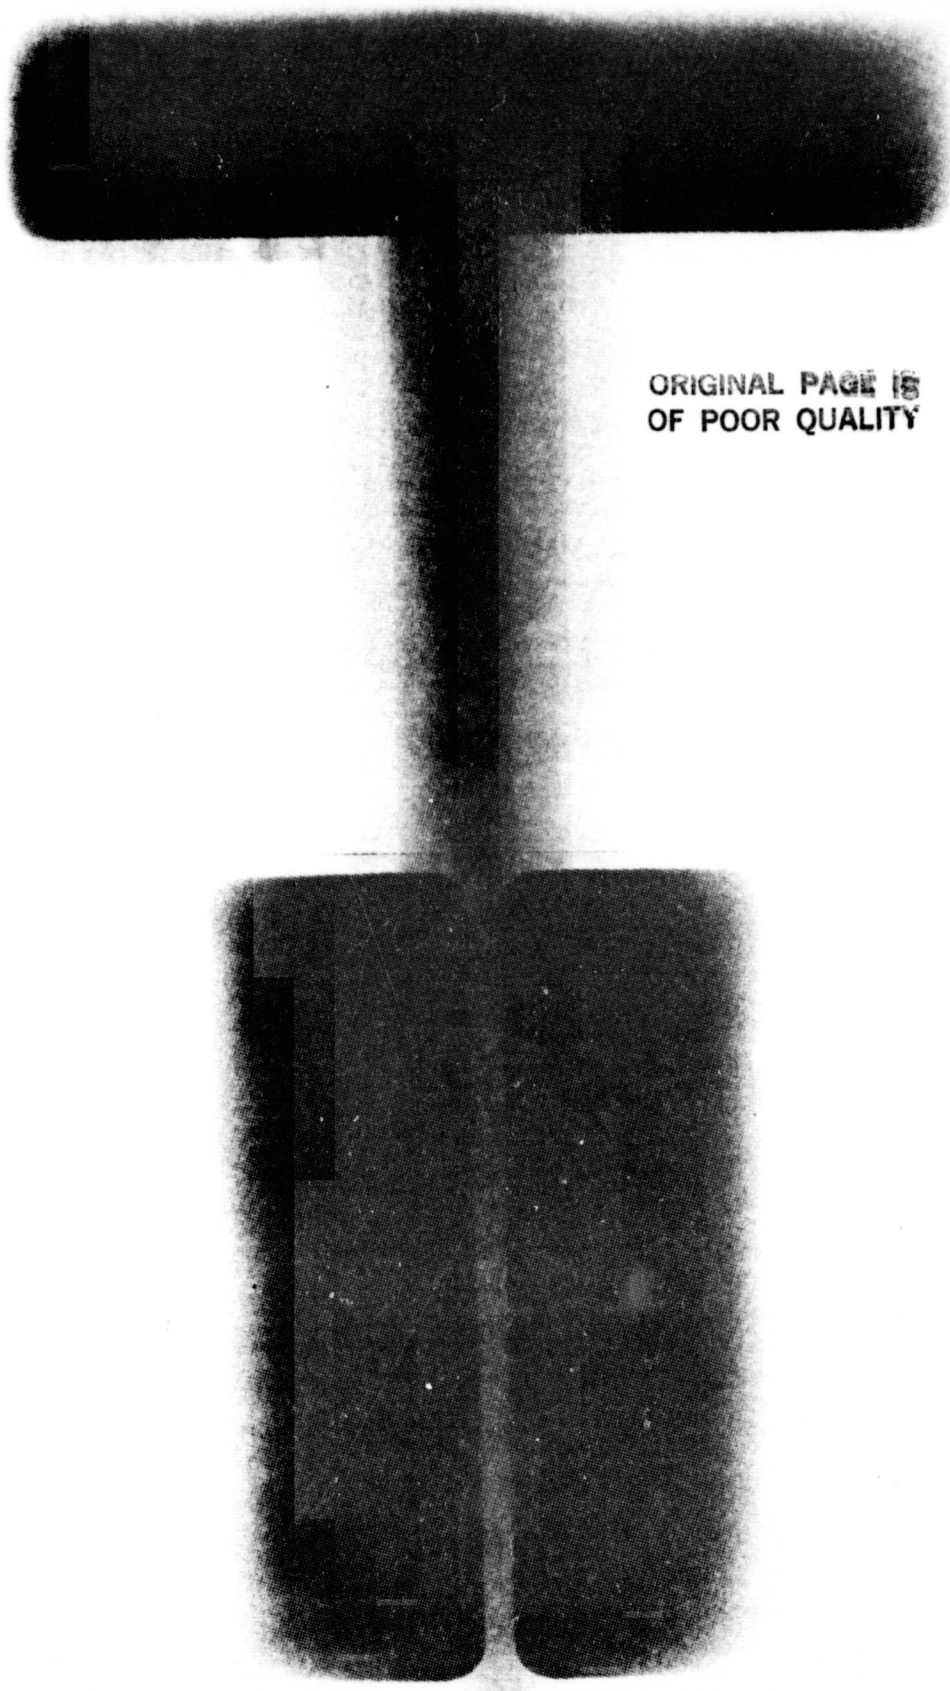
Figure 69. X-Ray of DS 15 After HIP.

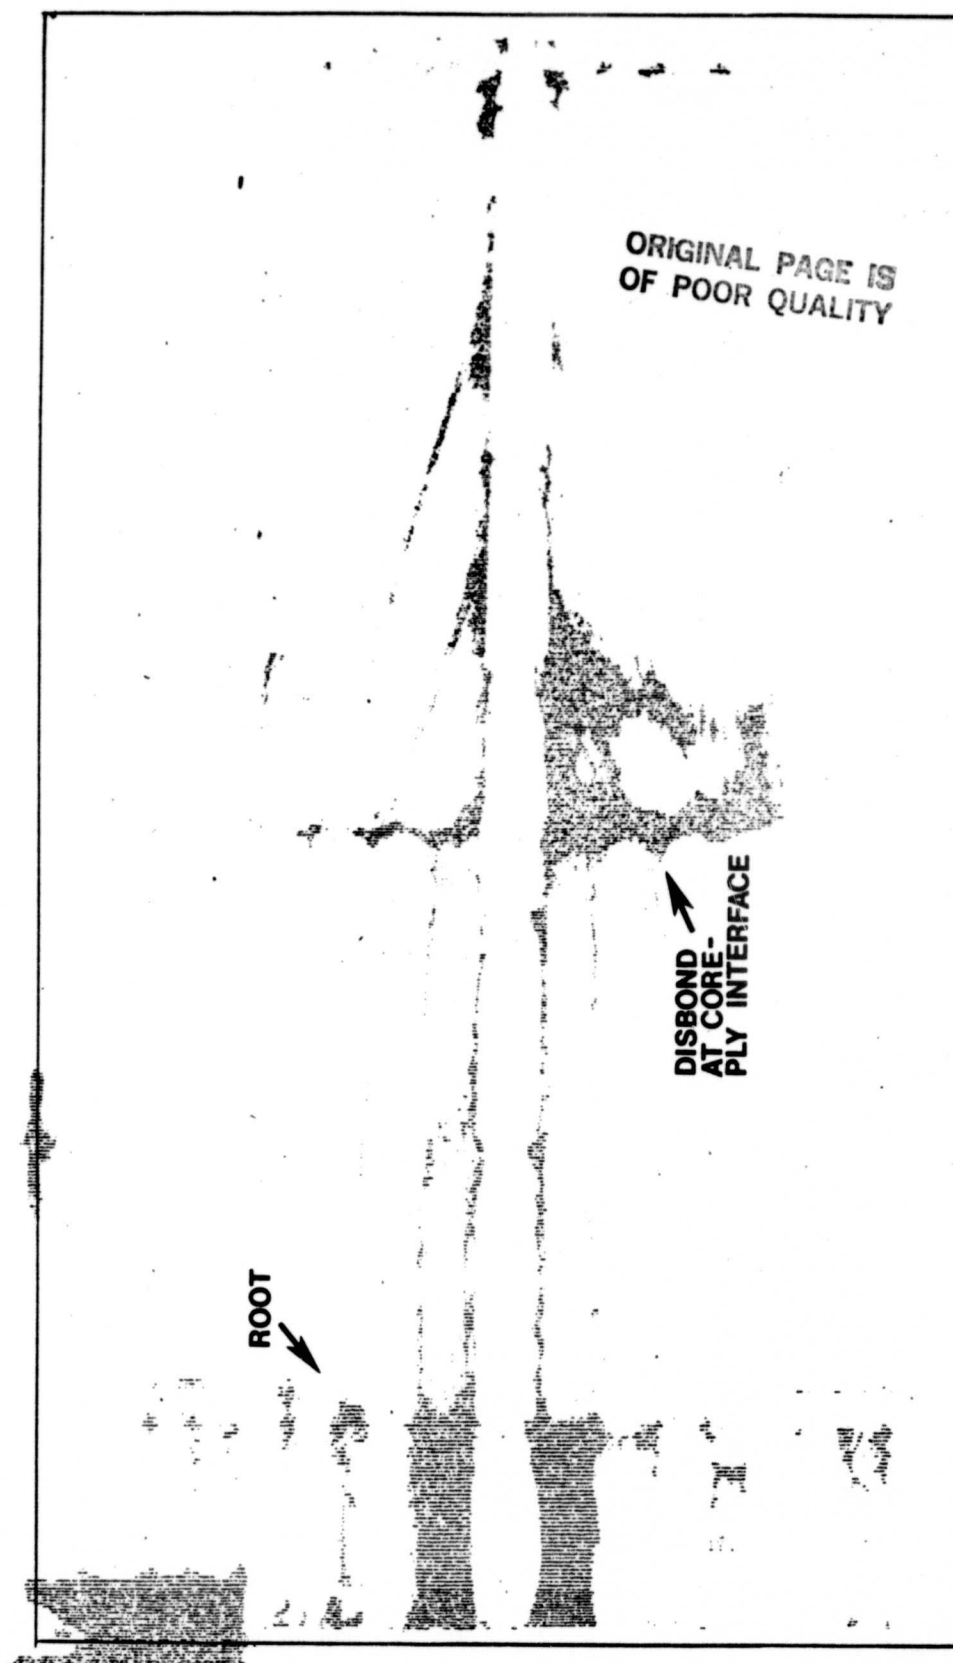
Figure 70. Ultrasound C-Scan of Diamond Specimen 15.

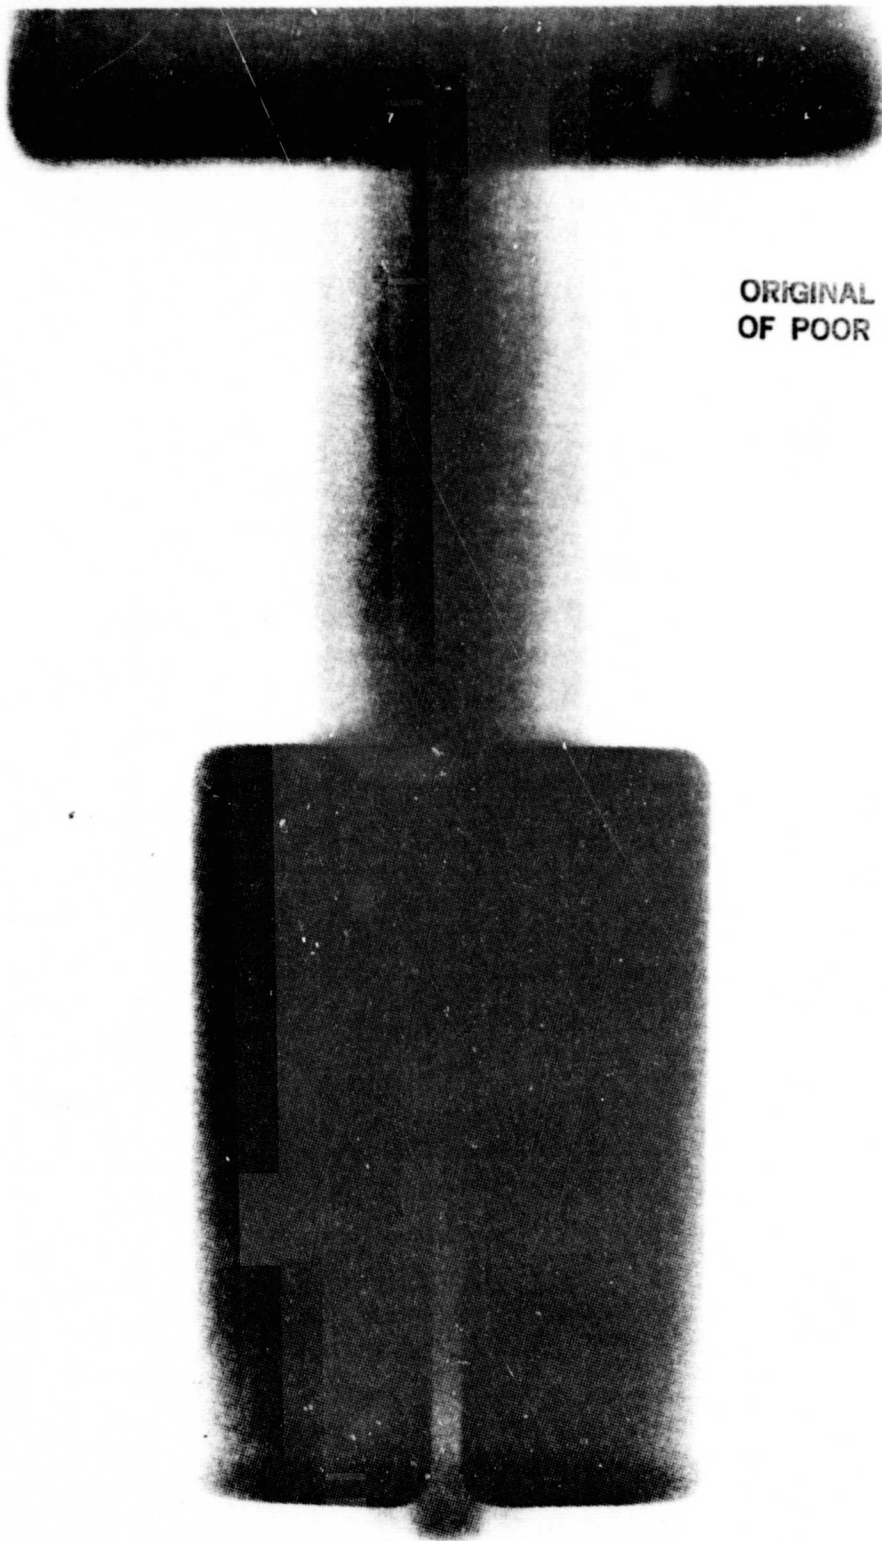
DS25 was evaluated by X-ray, C-scan and metallography. X-ray and C-scan indicated a well-bonded specimen with the proper core registry. The results are shown in Figures 71 and 72. Metallographic evaluations of some edge material indicated excellent bonding (see Figure 73) when using the conventional 96H₂O-2HNO₃-2HF etchant for titanium. A more aggressive etchant, 60H₂-35 HNO₃-5HF, revealed the "microporosity" observed at the bond line in other specimens when this etchant was used. This "microporosity" previously was attributed to adsorbed argon; however, this diamond specimen was not exposed to argon since it was seam welded in air.

Figure 71. X-Ray of DS 25 After HIP.

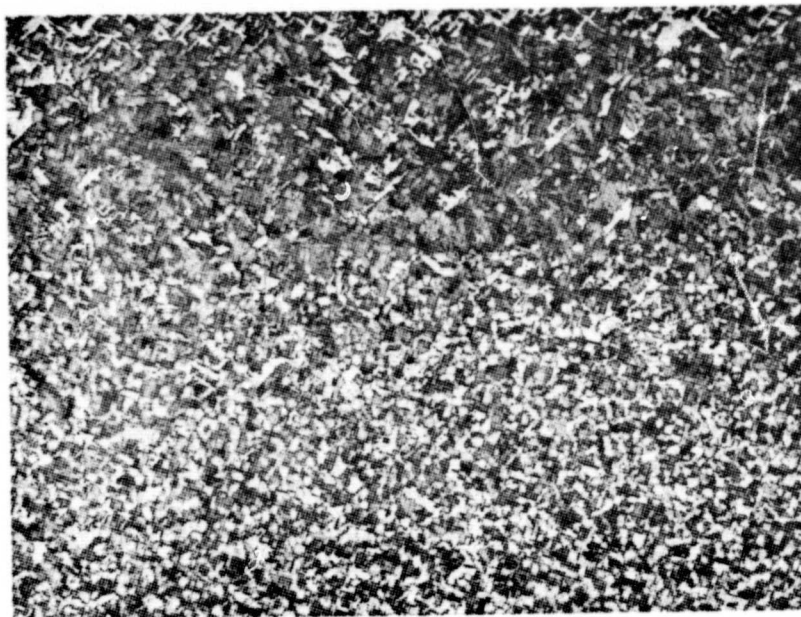
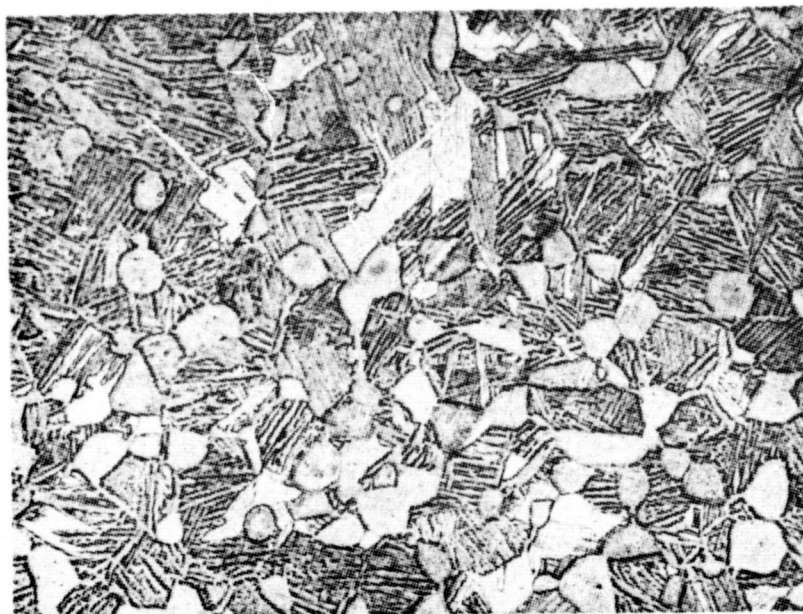
Figure 73. Typical Microstructure Along Edge in DS 25.
Etchant: $96\text{H}_2\text{O}-2\text{HNO}_3-2\text{HF}$.

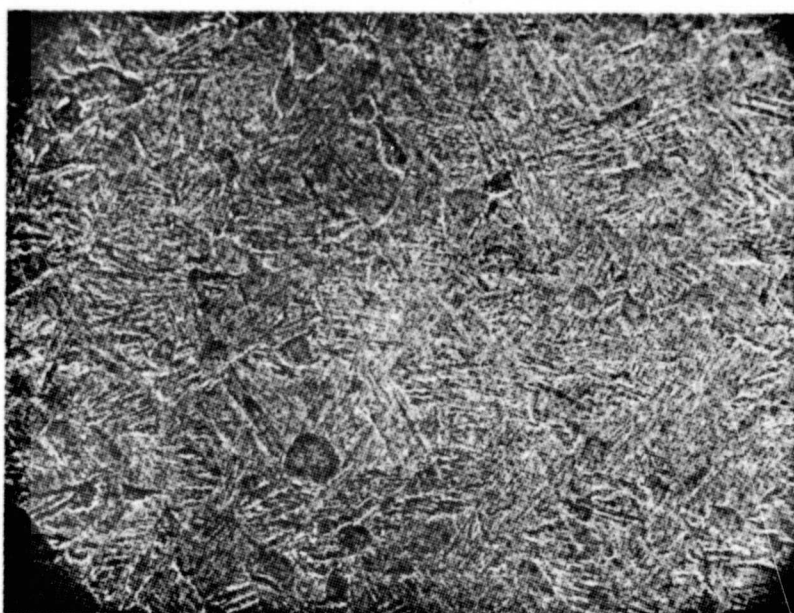
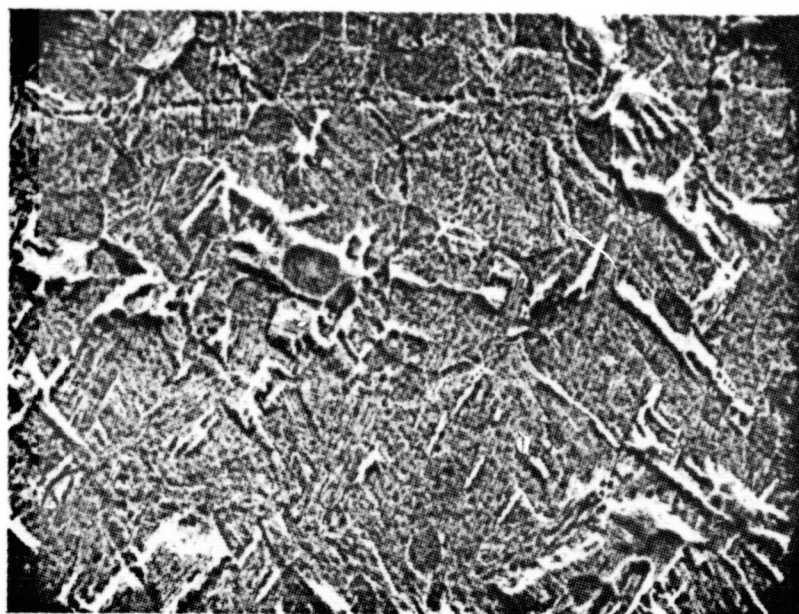
A SEM analysis of these micropores was conducted at TRW on DS25. Figure 74(a) shows an area that was etched very lightly to just reveal some structure. No evidence of micropores was found at the bond lines. The light etch was also given as an attempt to remove any "smeared" material as a result of the polishing. The specimen then was given a heavy etch that usually reveals the micropores at the bond lines. SEM photomicrographs were again taken at the same areas (see Figure 74(b)). The micropores are now readily visible. Figure 75 better illustrates these indications at a higher magnification. It is TRW's belief that these pores could be the result of preferential etching.

Figure 74. SEM Photomicrographs Depicting What Appears to be Preferential Etching at Bond Lines in DS 25. 500X

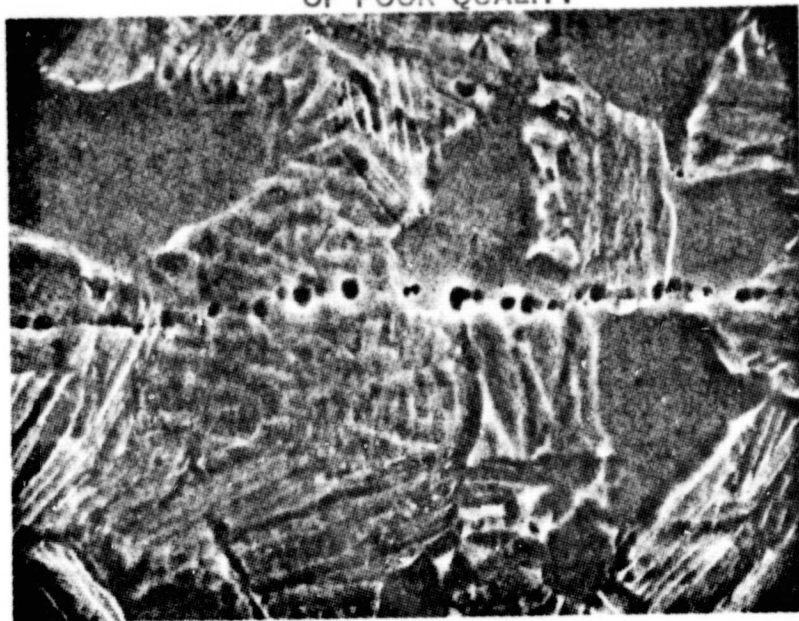
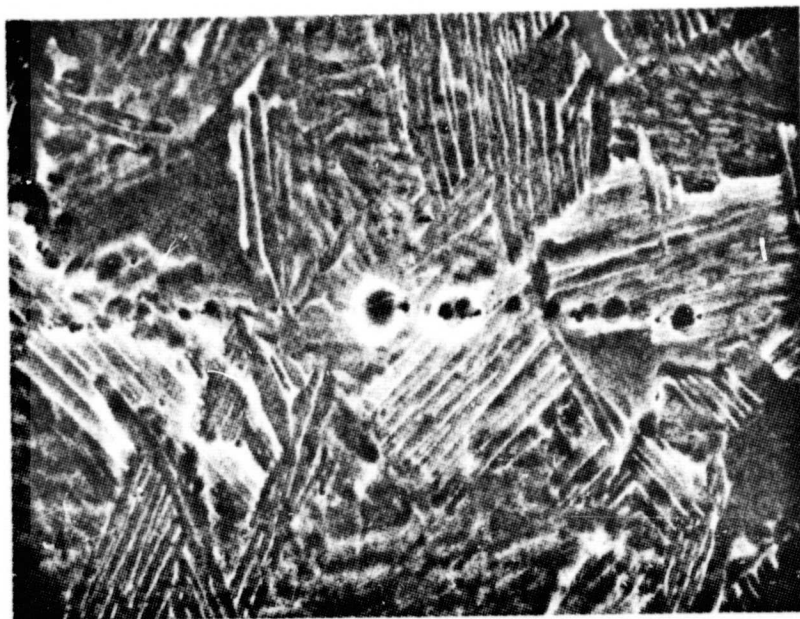
Figure 75. SEM Photomicrographs Illustrating That the Preferential Etching Leaves Voids in DS 25.
Etchant: $60 \text{ H}_2\text{O}-35\text{HNO}_3-5\text{HF}$ 2000X

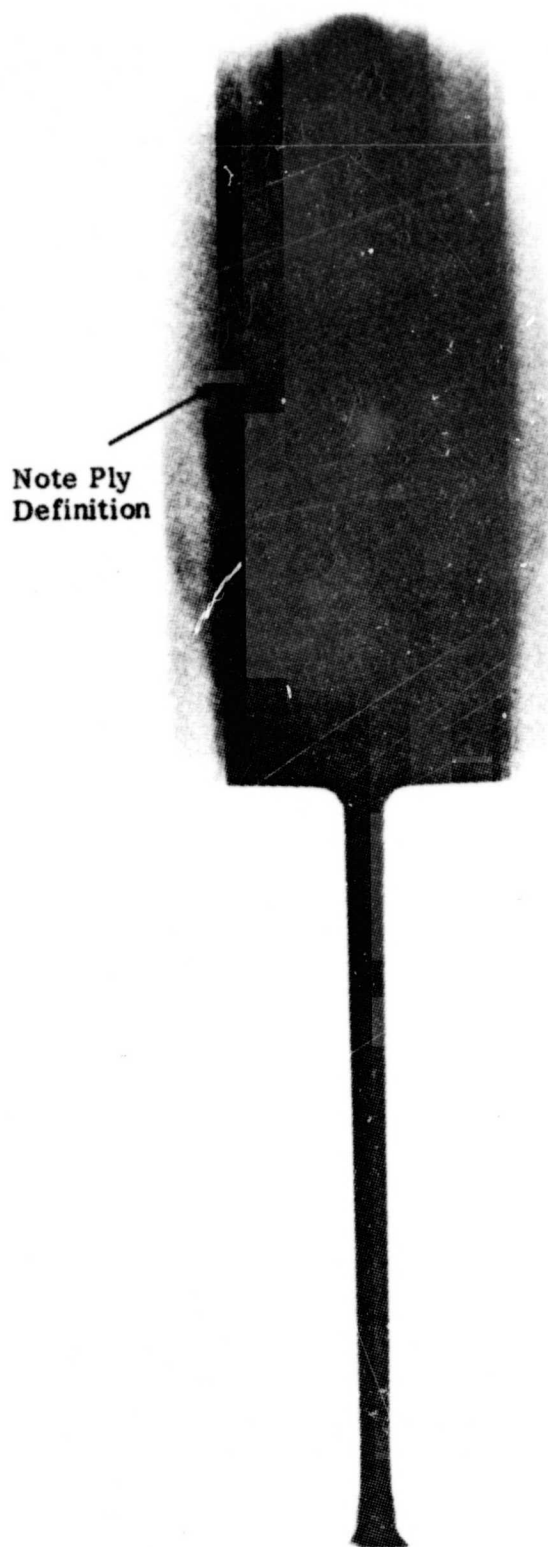
The six specimens that visually appeared bonded were further evaluated by X-ray and C-scan. Based on previous experience, the X-rays indicated that DS24 may not be entirely bonded as expected because of good ply delineation in the radiograph. The C-scan also is not as "clean" showing some indications. These observations are shown in Figures 76 and 77. Compare these results with those observed for DS25 (Figures 71 and 72) and the differences are obvious. The X-rays and C-scans for the remaining five diamond specimens are similar to DS25 and thus these specimens appear to be well bonded. Reviewing X-rays taken to verify core position before and after HIP, it was found that the cores remained in place during HIP; however, one of the diamond specimens (DS11) was found to have a core separation of 0.28-0.29-inch rather than the required 0.20-inch separation. This larger separation was also present prior to HIP based on the X-rays. A summary of the ten diamond specimens is given in Table IV.

Note Ply
Definition

Figure 76. X-Ray of DS 24 After HIP, Machining and Core Leaching.

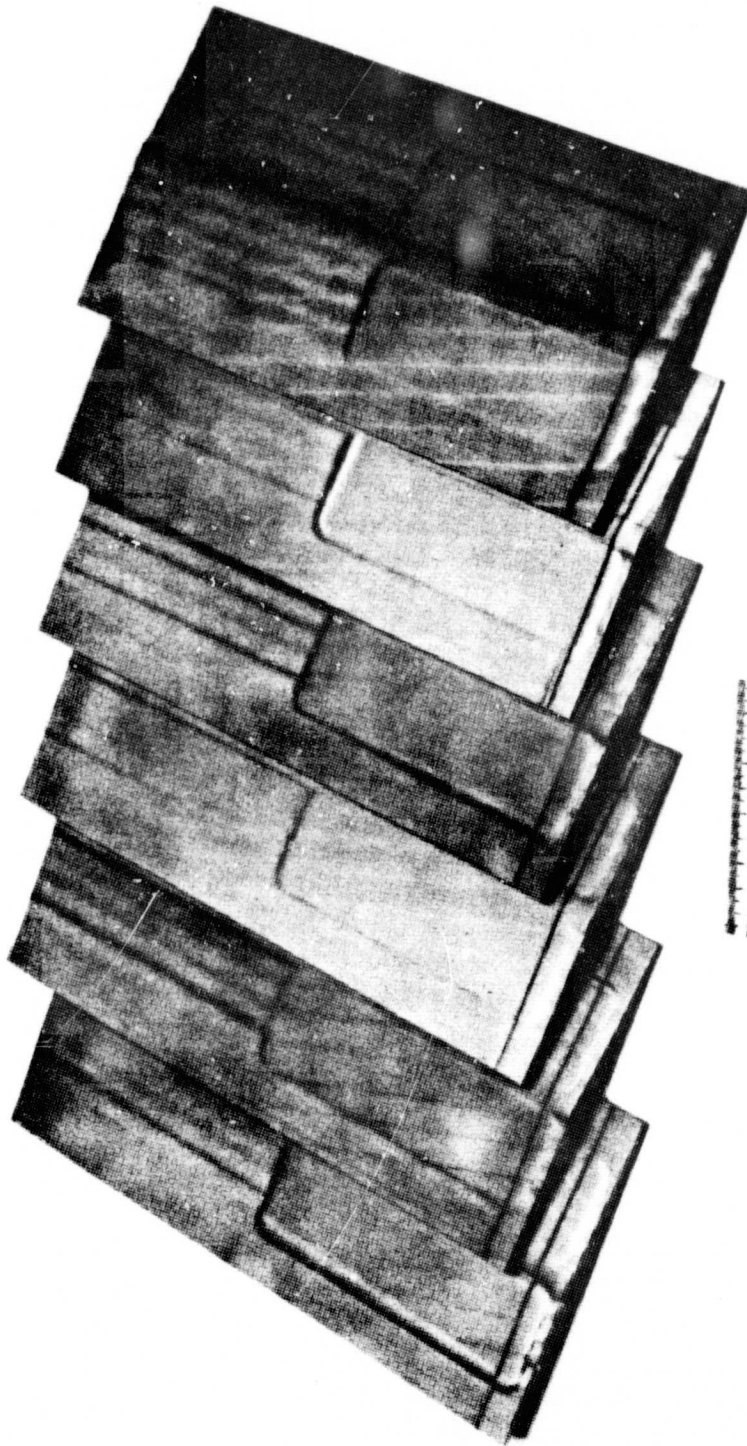
The last effort in this task was machining and leaching of the cores for the diamond specimens. DS8 and 25 not only were machined to length and width but also the surface was abrasive belt polished. Due to the thin wall design of the specimen and some shifting of the core in the short transverse direction, the surface was abrasive machined through the wall in one corner into the core. The original plan was to deliver these specimens as-HIP and the abrasive machining was an attempt to simulate the smoother surface to be produced on the blades after isothermal forging. The other six diamond specimens; DS11, 14, 16, 17, 21 and 24; were machined and leached successfully and are shown in Figure 78 prior to shipment to P&WA. Abrasive belt polishing of the surface was not performed for these six specimens.

Figure 78. Six Machined and Core Leached Diamond Specimens.

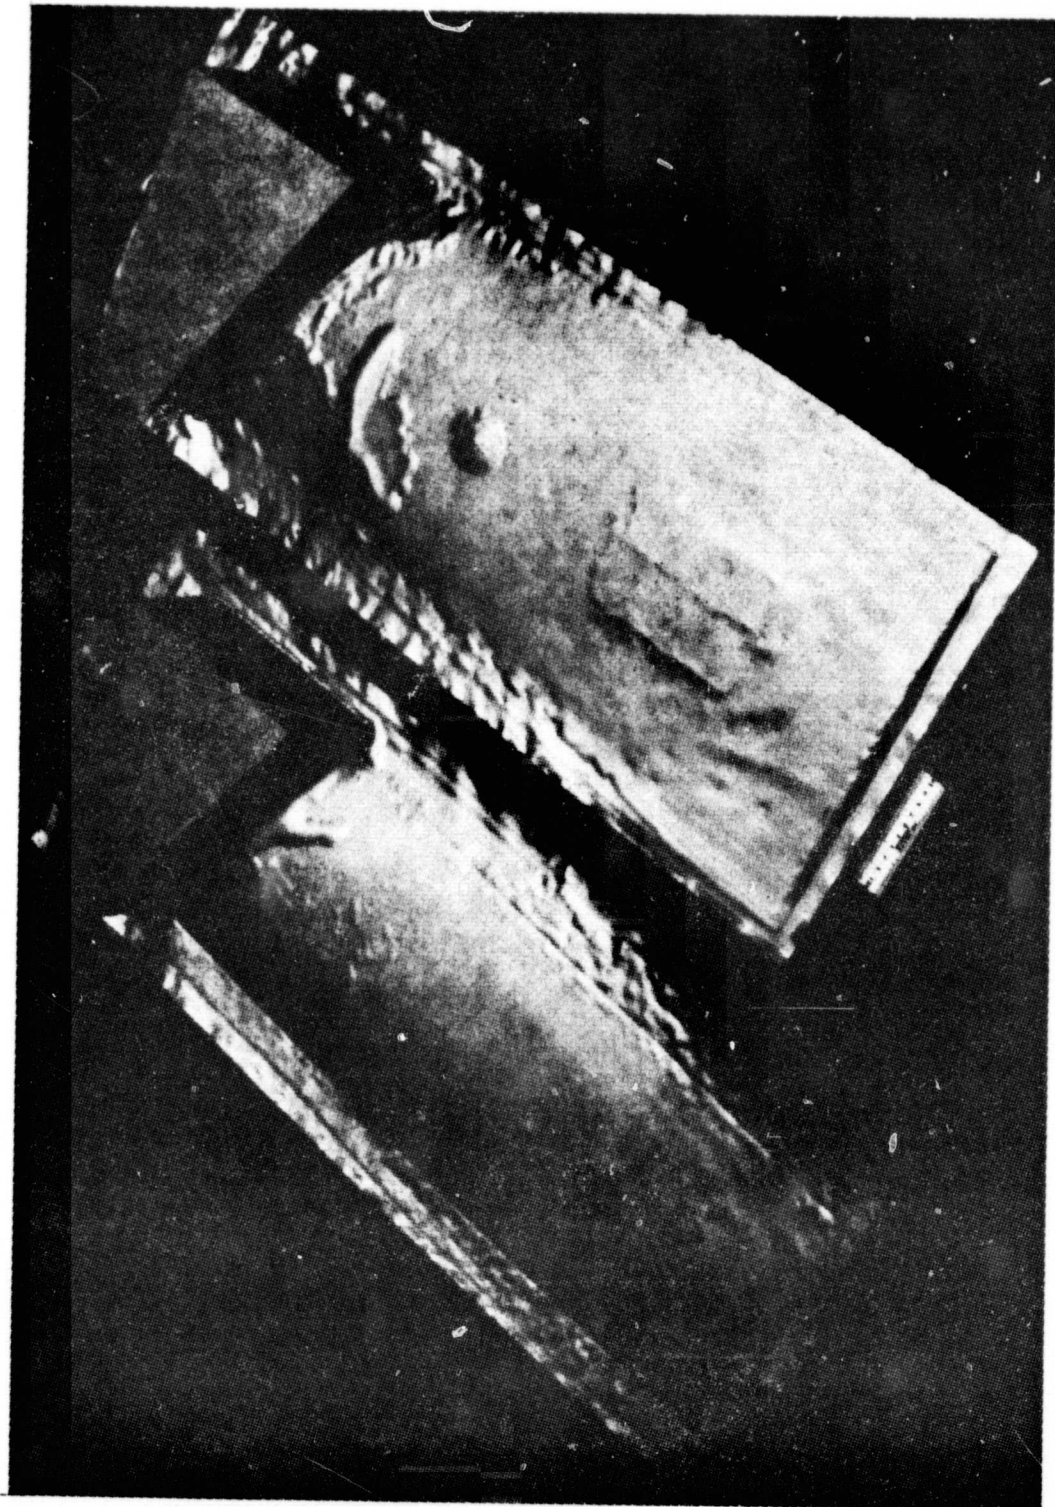
The blade assemblies after HIP are shown in Figure 79. Both assemblies leaked during HIP, probably early into the cycle. The HIP assemblies were again leak checked using a mass spectrometer. A hole was drilled at the root end and a vacuum was pulled on the assembly. Assembly was leak checked using helium. Both blades leaked at the root end but the leaks were large enough to prevent exact location using the mass spectrometer. The assembly was then pressurized with helium from the inside and a leak check solution (soap solution) was applied at all weld areas. This solution pinpointed two weld failures in each blade. Both blades failed along the TIG weld-base metal interface near the tube exit and also failed at a spot weld that was inside the seam welded area. Figure 80 illustrates typical locations of the two leak sources for both assemblies. These areas were sealed and the entire assembly was leak checked again using a mass spectrometer. No other leaks were found. Obviously, no spot welds should be within the seam welded perimeter. The few spot welds inside the seam welds on these initial assemblies were unintentional. The poor condition of the blades after HIP limited any other evaluations.

Figure 79. First Iteration Blades After HIP.

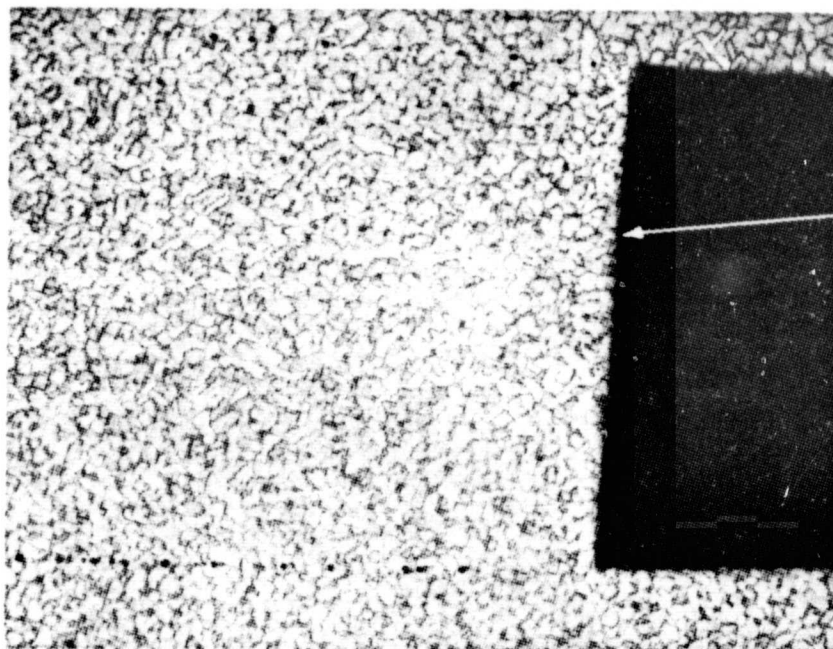
cores remained in place during shipping and HIP. Attempts were made to disassemble the blade after HIP but a considerable amount of bonding had occurred. The Figure 82 photomicrograph shows the bond lines with the porosity due to argon. Note also the ply ending which indicates a lack of titanium ply flow. These observations appeared to be typical of blade 3.

Figure 82. Typical Microstructure and Bonding Conditions Found in Blade 3.
